SAN FERNANDO, CALIFORNIA,
EARTHQUAKE OF
9 FEBRUARY 1971

GORDON B. OAKESHOTT, *Editor*
CALIFORNIA DIVISION OF MINES AND GEOLOGY

BULLETIN 196
California Division of Mines and Geology
Resources Building, Sacramento, California

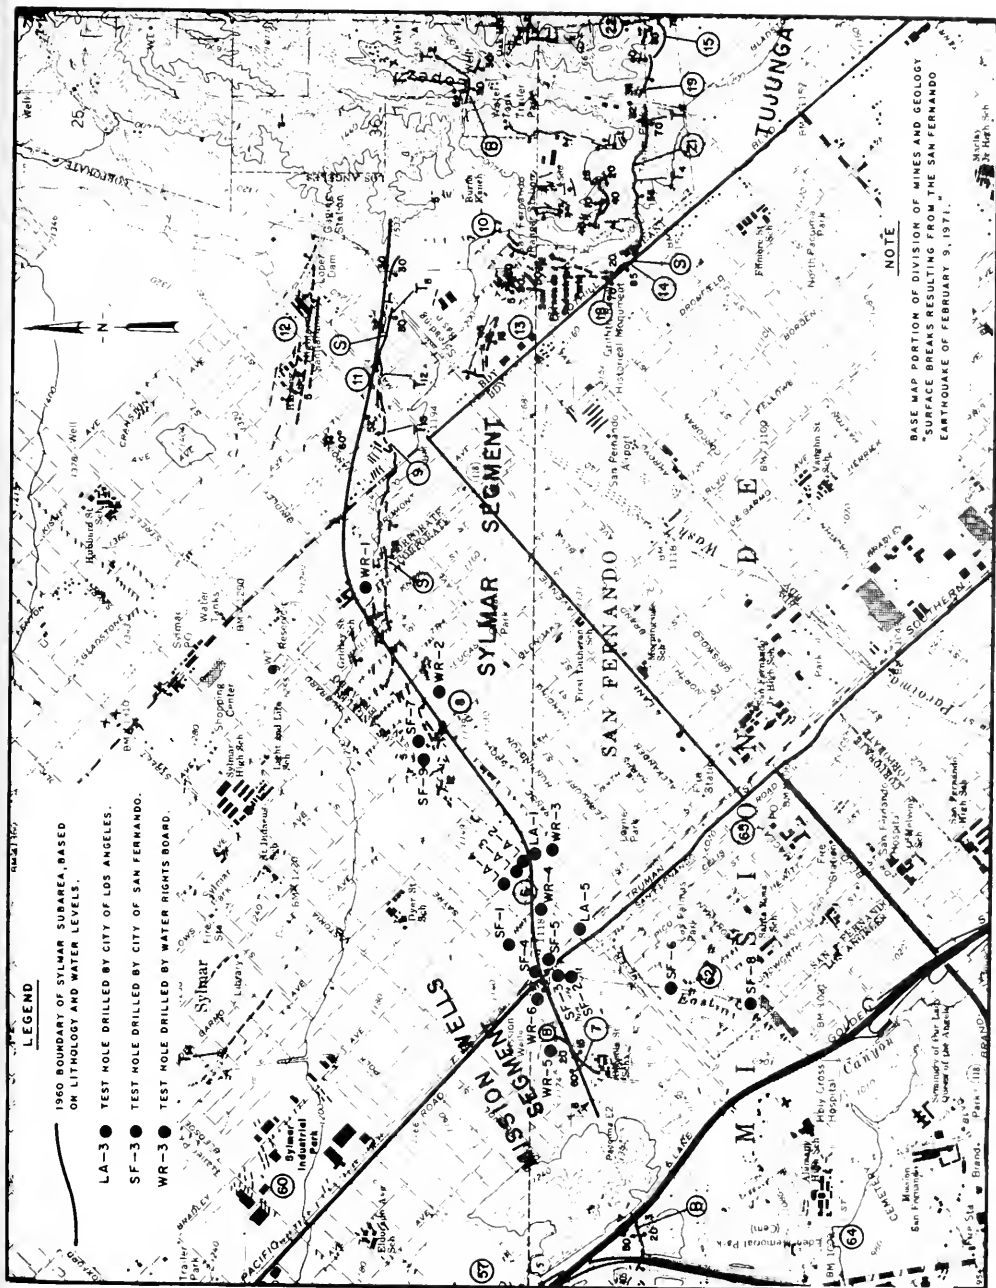
A discordance in the ground water surface was noted in the area northeast of the city of San Fernando during previous ground water investigations. As stated, a series of 20 bucket-auger holes was drilled to supplement the available water-well data. The line representing the break in water surface, which was originally used as the boundary between the Sylmar and San Fernando subareas, closely fits the surface faulting in the Mission Wells segment and approximates the faulting in the Sylmar segment of the 1971 San Fernando fault. The gap between the two fault segments was the area most intensively explored with bucket-auger borings and the break in water surface was most accurately determined. It is suggested that, in this area, the break in water surface be used as the inferred location of the missing fault trace (see figure 6). The greatest deviation between the trace of surface faulting and the line originally mapped occurs in the vicinity of Foothill Boulevard. However, in that area, water level data were lacking, and the break was located only by geologic judgment based on outcrops of nonwater-bearing formations located farther to the east near Pacoima Wash.

Figure 6. Relationship between surface breaks of San Fernando earthquake and boundary of Sylmar subarea.

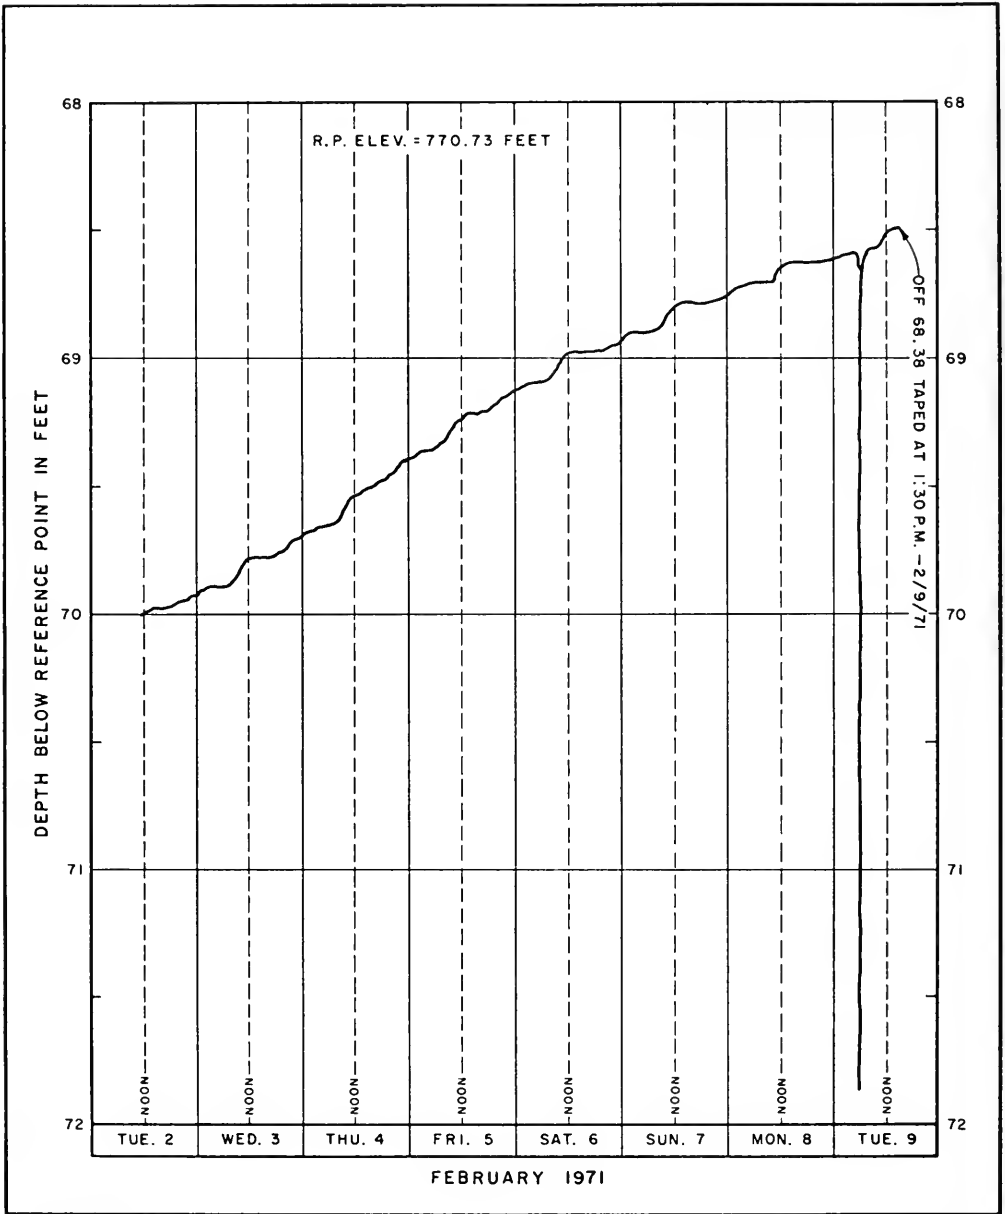
Figure 7. Recorder chart for well, showing effect of earthquake.

continuous water-level recorders in southern California. Well no. 4915, located in the Consolidated Rock Products Sun Valley pit below Hansen Dam, is the closest well to the Sylmar area that was equipped with a continuous water-level recorder. This well, 3 miles south of the ground rupture along the Tujunga segment of the San Fernando fault, recorded a deflection of about 0.5 foot in the water surface during the earthquake. The water surface returned to its original level immediately after the main shock. Interpretation of the recorder chart and other well measurements by personnel at the City of Los Angeles Department of Water and Power indicates that there were no permanent changes in ground water elevations directly attributable to the February 9, 1971, earthquake. The short-term water-level fluctuation within recorder well 4915 was attributed to ground shaking and vibration of the well structure itself. The Cities of Glendale and Burbank indicated that there were no earthquake-induced effects noted in any of their water wells.

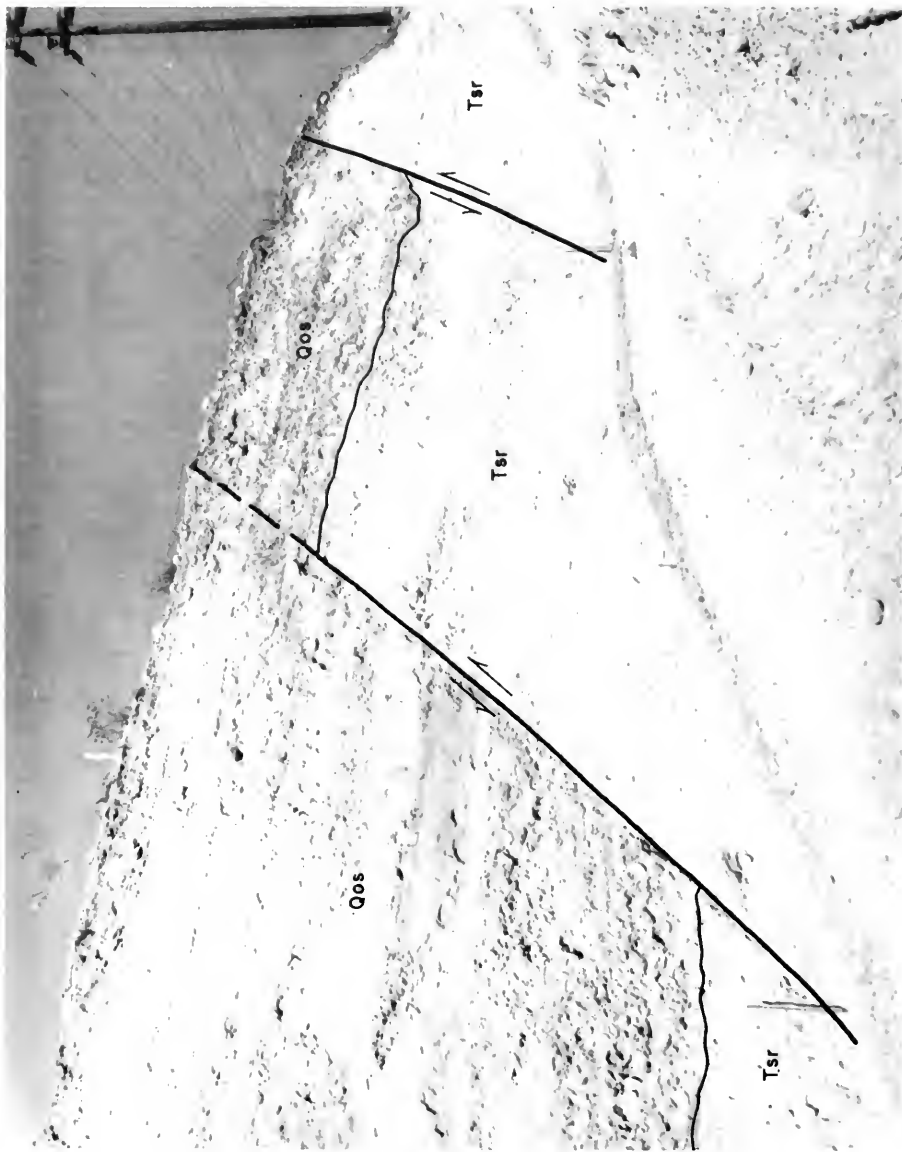
Photo 4. View northwest toward the newly cut face of an old borrow pit just south of the west abutment of Lower San Fernando Dam. Here two faults cut sand and stony conglomerate near the base of the Sunshine Ranch Member of the Saugus Formation and unconformably overlying nearly flat-lying, older alluvium. The strike of the lower left is about 1.1 m (3.5 feet) tall. The bedding of the Sunshine Ranch Member dips 55 degrees north-northwest away from the viewer. The displacement on these faults represents inelastic response to Late Quaternary uplift of the Mission Hills anticline which lies to the east (right) of this site.

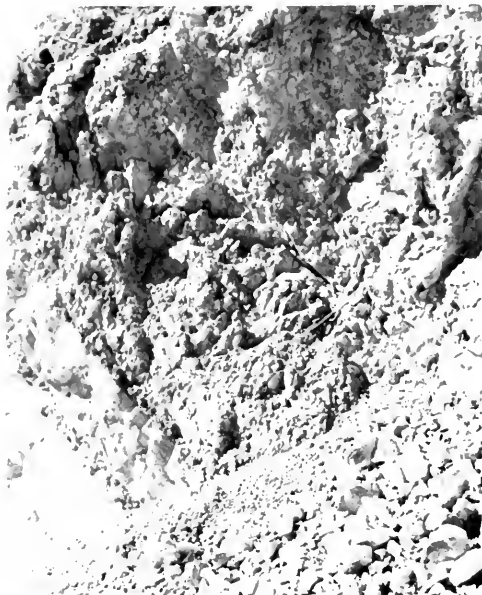
Photo 5. A sheared clay-rich unit exposed in a trench about 200 feet west of the west abutment of Lower San Fernando Dam. This is one of the few such beds in the basal part of the Sunshine Ranch Member of the Saugus Formation. It is one of a set of northeast-trending sheared beds and faults crossing the bed of Lower Van Norman Reservoir, and almost certainly was a site of displacement during the uplift of the Mission Hills anticline. Note the well-exposed shear plane near the head of the hammer.

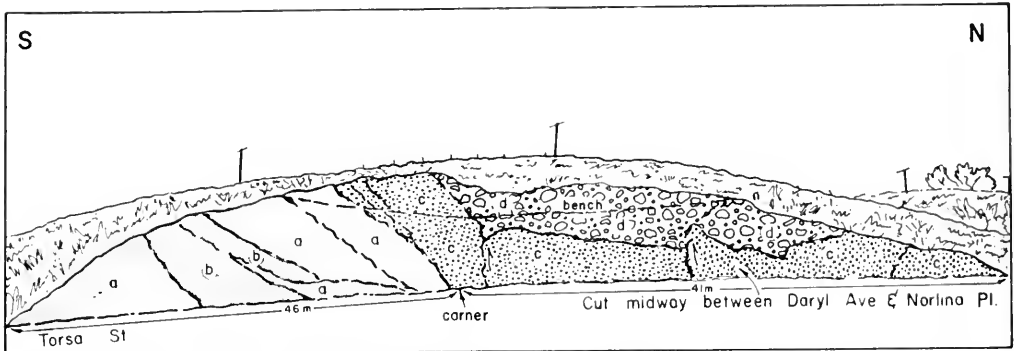
Figure 3. The west end of the graded oreo on Torsa Street as it was late in 1967. The Torsa Street break (see plate 3, location 3) occurred just south (to the left) of the Torsa Street face of this cut. Units a and b are typical of the upper part of the Saugus Formation. Unit a is light-brown siltstone. Unit b is light tan sand and siltstone. Unit c is tan siltstone and soft sandstone with beds of pebble conglomerate. The pebble beds are composed predominantly of rounded, tabular, gray silty shale fragments and subordinate amounts of angular parceloneous shale fragments. Unit d consists of crudely layered, angular Modelo shale fragments and sandstone concretions, lithologically similar and probably equivalent to the uppermost beds of the Saugus Formation (photos 1 and 2). The wavy dashed lines are planes of shearing with one-barbed arrows showing relative displacement where this is reasonably certain. The sole of the Santa Susana thrust once lay a short distance above these beds; its eroded trace now lies about 365 m (1200 feet) to the north and west of this site.

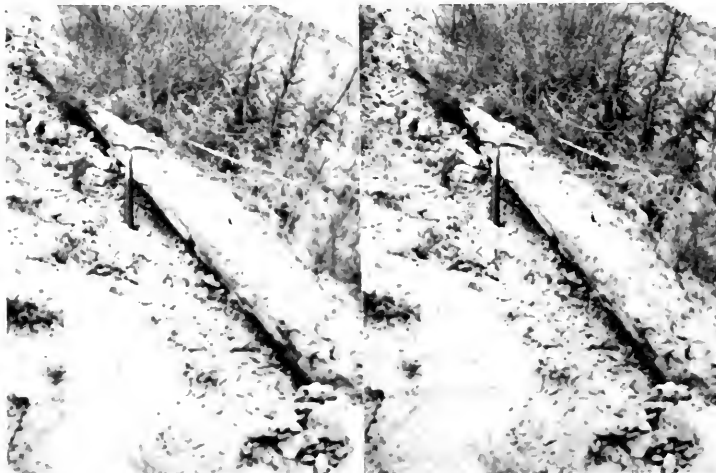
Photo 6. A stereoscopic photo of the break on bedding planes in the Sunshine Ranch Member of the Saugus Formation in a freeway cut just east of Lower Van Norman Reservoir (57).

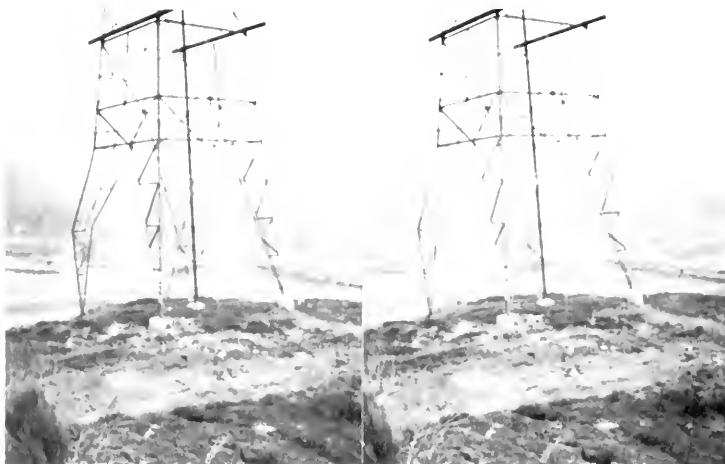
Photo 8. A stereoscopic photo showing a view northeast along the zone of the Santa Susana thrust. The damaged northwest leg of the tower suggests a force from the northwest with a possible upward component. San Fernando Pass and the Balboa Boulevard overpass are in the background.

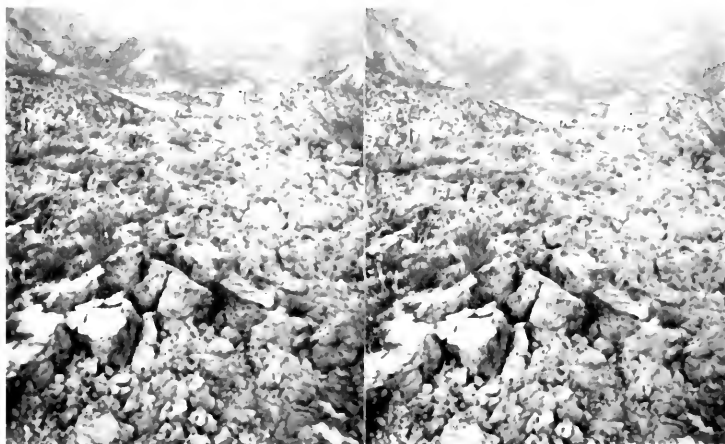
Photo 9. A stereoscopic photo of the shattered-ridge effect on a ridge east of the mouth of Bee Canyon. Cascade oil field is in the background. Note light-colored remnants of the pre-earthquake surface.

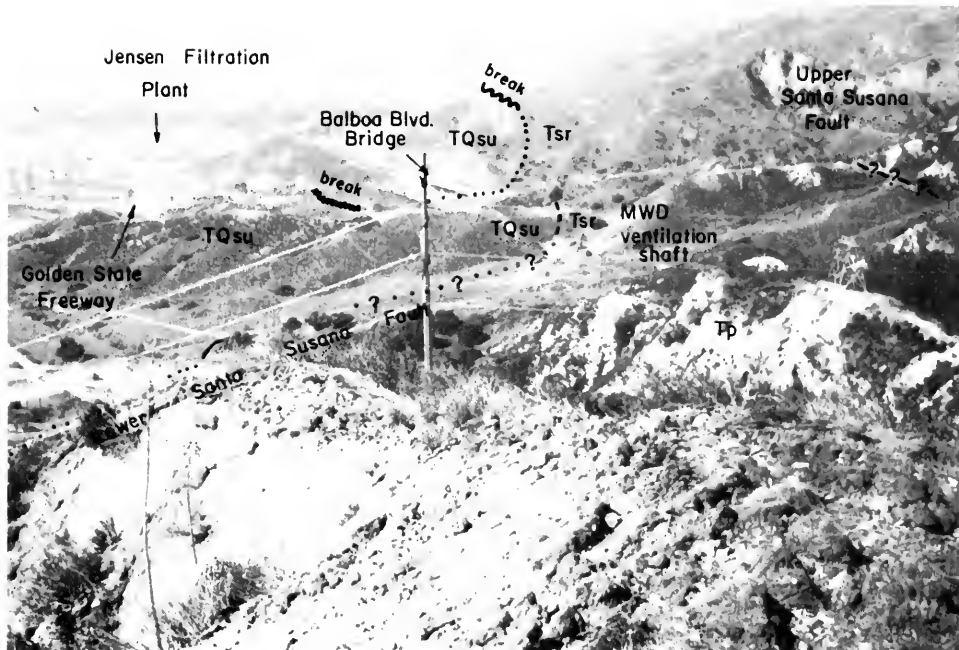
Photo 1. View southwest from north of Grapevine fault down south slope of San Gabriel Mountains over ridge top underlain by terrace deposits (Pacima Formation?). The thin veneer of soil on ridge crest shattered during earthquake shaking and slid down the steep slope. Light-colored ridges to right are resistant sandstone and conglomerate of the Pica Formation (Tp). In background, northeasterly breaks along Santa Susana fault zone are visible; along lower fault, Sunshine Ranch Member of Plio-Pleistocene Saugus Formation (Tsr) is thrust southeast over younger upper member (TQsu).

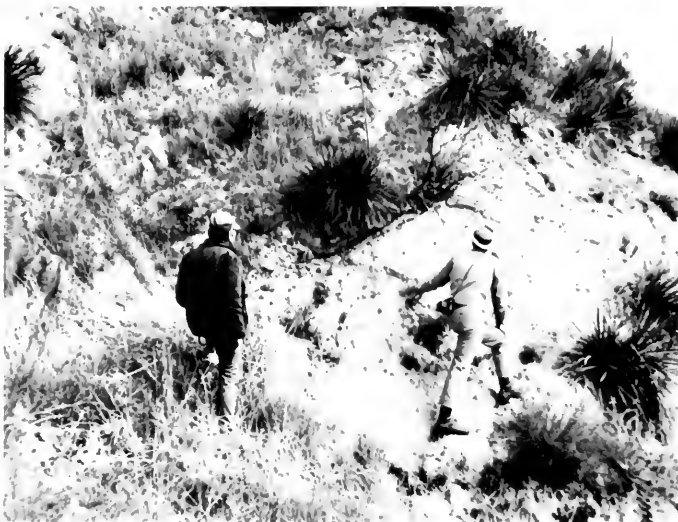
Photo 2. Displacement of lower Santa Susana fault during earthquake was about 8–10 cm (3–4 inches) of left-oblique slip where well exposed beneath yucca plant in middle ground. Much of the bare area shown on the right was caused by rockfalls during shaking. View northeast is about 75 m (250 feet) northeast of Foothill Boulevard in San Fernando Pass (locality 20). Fault is well defined by a very thin white layer of caliche, with nearly vertical beds of lower, Sunshine Ranch Member of Saugus Formation thrust over gently southeast-dipping upper member of Saugus Formation of Pliocene-Pleistocene age. Fault break was represented by mole track in grass-covered ground to left of point where photograph was taken. Photo by James E. Kahle.

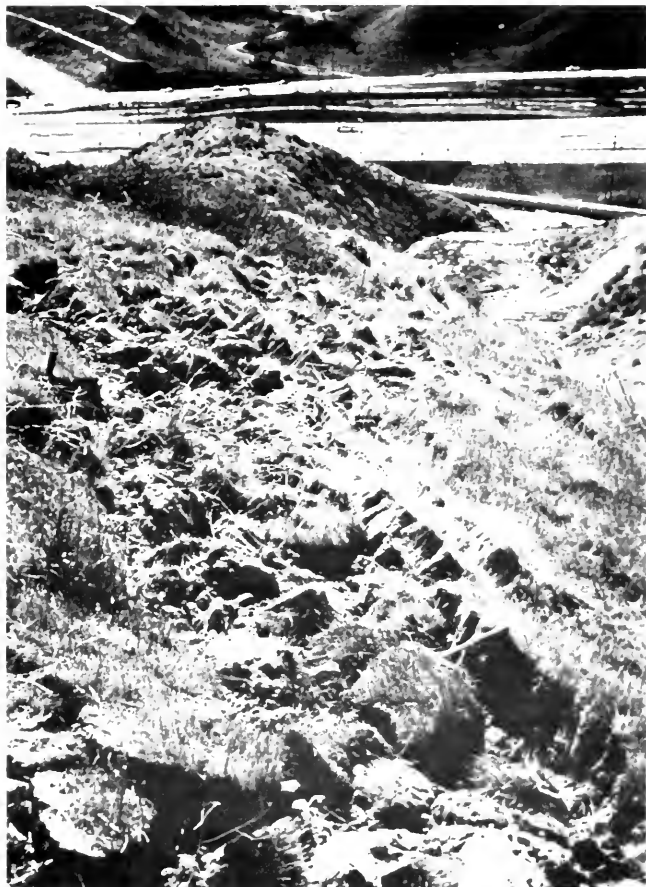
Photo 3. Where shaking was intense during earthquake, soil mantle along crests of ridges shattered or popped apart and gravitated downslope. Scene shown here is about 230 m (750 feet) northwest of break along Santa Susana fault (out of picture to left); the fault trends southwest beneath fill for Golden State Freeway in San Fernando Pass in left distance and extends southwest up canyon shown at center of top of photograph. Photo by Allan G. Barrows.

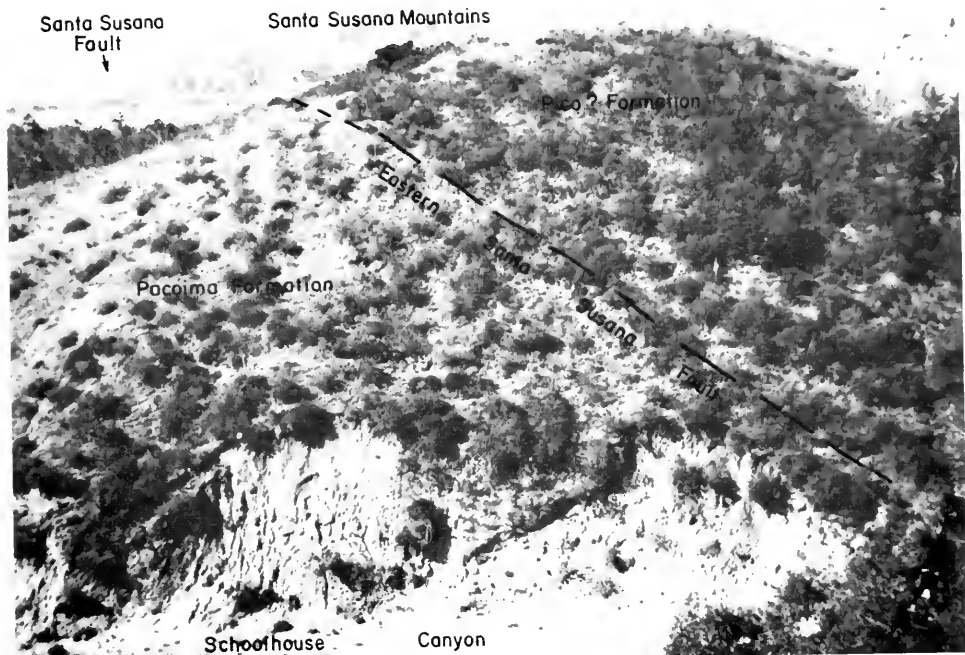
Photo 4. View west-southwest, about 300 m (1000 feet) north of western end of Olive View Hospital property (locality 34). Eastern lower Santa Susana fault dips about 45° N. through ridge on west side of Schoolhouse Canyon. Highly folded, fractured, and overturned (?) sandstone, probably Pico Formation, is thrust over relatively undisturbed, north-dipping conglomerate of Pacoima Formation. Small cross fractures, slight warping, and landslides along trace where shown on side of ridge suggest slight activity along fault in this area. From bottom of canyon to top of hill is about 40 m (125 feet) vertically.

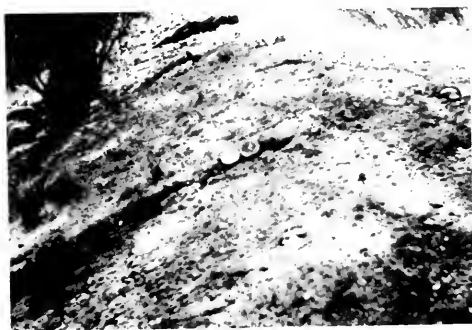
Photo 5. View south showing western part of fault break which is about 370 m (1200 feet) north of western edge of Olive View Hospital complex (locality 36). Break strikes N. 80° E. for about 45 m (150 feet) and dips 75° S., with a maximum reverse offset during earthquake of 2 cm ($\frac{3}{4}$ inch). At most easterly point of break, fault clearly shows Pliocene Towsley or Pico Formation displaced northward over Pleistocene Pacoima Formation or older alluvium.

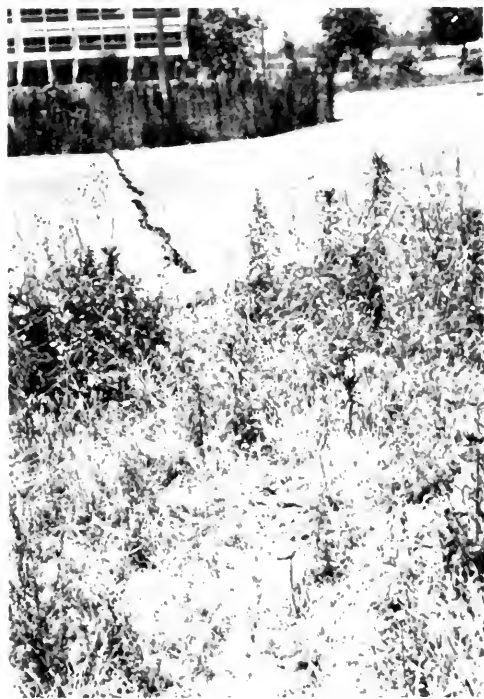
Photo 6. View west-southwest from 75 m (250 feet) east of main building of Olive View Hospital (locality 40). Crack visible in foreground is down on south as much as 1 cm (0.4 inch). Brunton compass for scale.

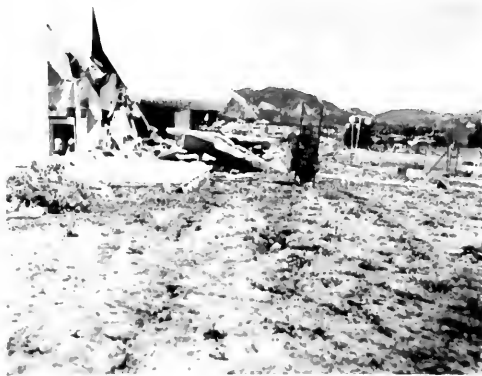
Photo 7. View east at southwest corner of Olive View Hospital main building; ground cracks formed as a result of spreading out and bowing up of fill to south of building, probably in response to movement of fill beneath building during shaking and collapse of south stairwell (barely visible). Photo by James E. Kahle.

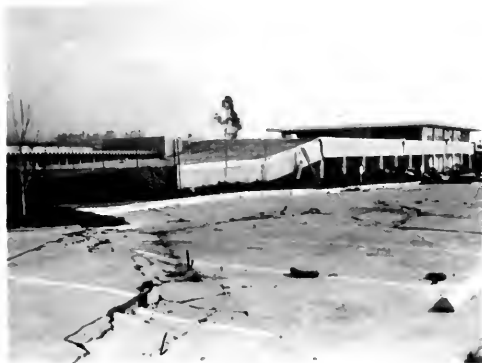
The strong curvilinear cracks to the northeast of the Juvenile Hall extended southwest at least 900 m (nearly 3000 feet) to the Pacific Intertic Terminal in a zone as wide as 450 m (nearly 1500 feet) (photo 8).

Photo 8. View northeast from front parking lot of San Fernando Juvenile Hall shows severe damage to building. It also shows northwest margin of ground cracking caused by shaking and consequent movement of ground in right part of photograph to southwest toward camera. Cracks in foreground show right-lateral displacement; those on opposite end of parking lot (off the right side of photograph) show left-lateral displacement. Photo by James E. Kahle.

Such strong features of ground cracking in moist fine-grained sandy alluvium, along with development of sand boils at the surface, imply that liquefaction of sub-surface strata occurred during shaking, causing gravitational lurching or sliding. Structures built on the ground, thus, were damaged by a combination of shaking and ground movement.

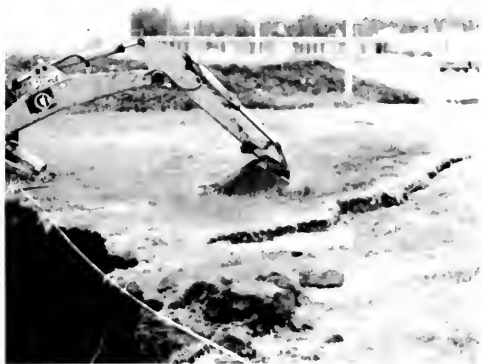
The alluvium slightly southwest of the Southern Pacific railroad tracks is known to be at least 41 m (135 feet) deep, as a California Division of Highways drill hole to that depth did not reach bedrock. The depth to the ground water table is less than 3 m (10 feet) southwest of the tracks and deepens to the northeast (Brown, this Bulletin). The water table deepens to 7.5-9 m (25-30 feet) near the northeast edge of the Juvenile Hall ground cracks. Trenches (T 9, T 10, and T 11) dug across cracks in the Juvenile Hall area were examined by Allan G. Barrows and James E. Kahle. The trenches showed cracks descending to moist gravelly layers and layers of moist silty sand from depths of 1.7 m (5.5 feet) to at least 2.7 m (9 feet), the greatest depth of the trenches (photos 9 and 10).

Photo 9. View north; ground cracks in yard of San Fernando Juvenile Hall. Cracks resulted from sliding and settling along wet, sandy layers of alluvium during shaking. Strongest cracks did not extend beneath floor of trench (T9). Close-up view shown in photo 10. Photo by James E. Kahle.

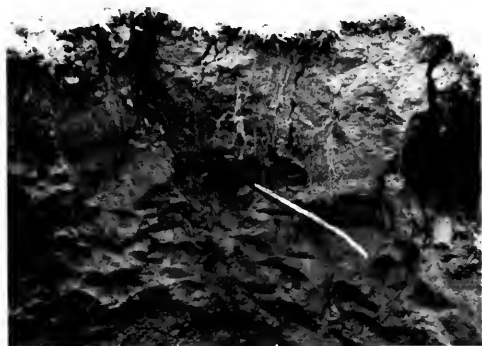
Photo 10. Close-up view of east side of trench in photo 9 showing cracks. Photo by James E. Kahle.

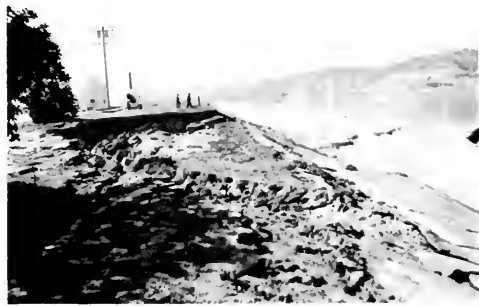
Southwest of the Juvenile Hall area, the cracks seem to diminish in strength at the flood control channel at the northeastern edge of the Pacific Intertic Terminal (15). Southwest of the channel, the strongest effects may lie in alluvium beneath fill, which here extends to Van Norman Reservoir and around its north edge (plate 2). These effects may extend to the surface south of the fill as numerous sand boils, which were noted in the north part of the lake bottom after the reservoir was partially drained. On the other hand, these sand boils may have been caused by subsurface effects unrelated to ground cracks to the northeast, or they may have been caused by intense sliding of the bank around the north edge of the reservoir (photo 11).

Photo 11. View south shows landslide in west side of small peninsula extending out into Upper Van Norman Reservoir; this area is part of fill at north edge of reservoir which failed (locality 13, plate 3). Photo by James E. Kahle.

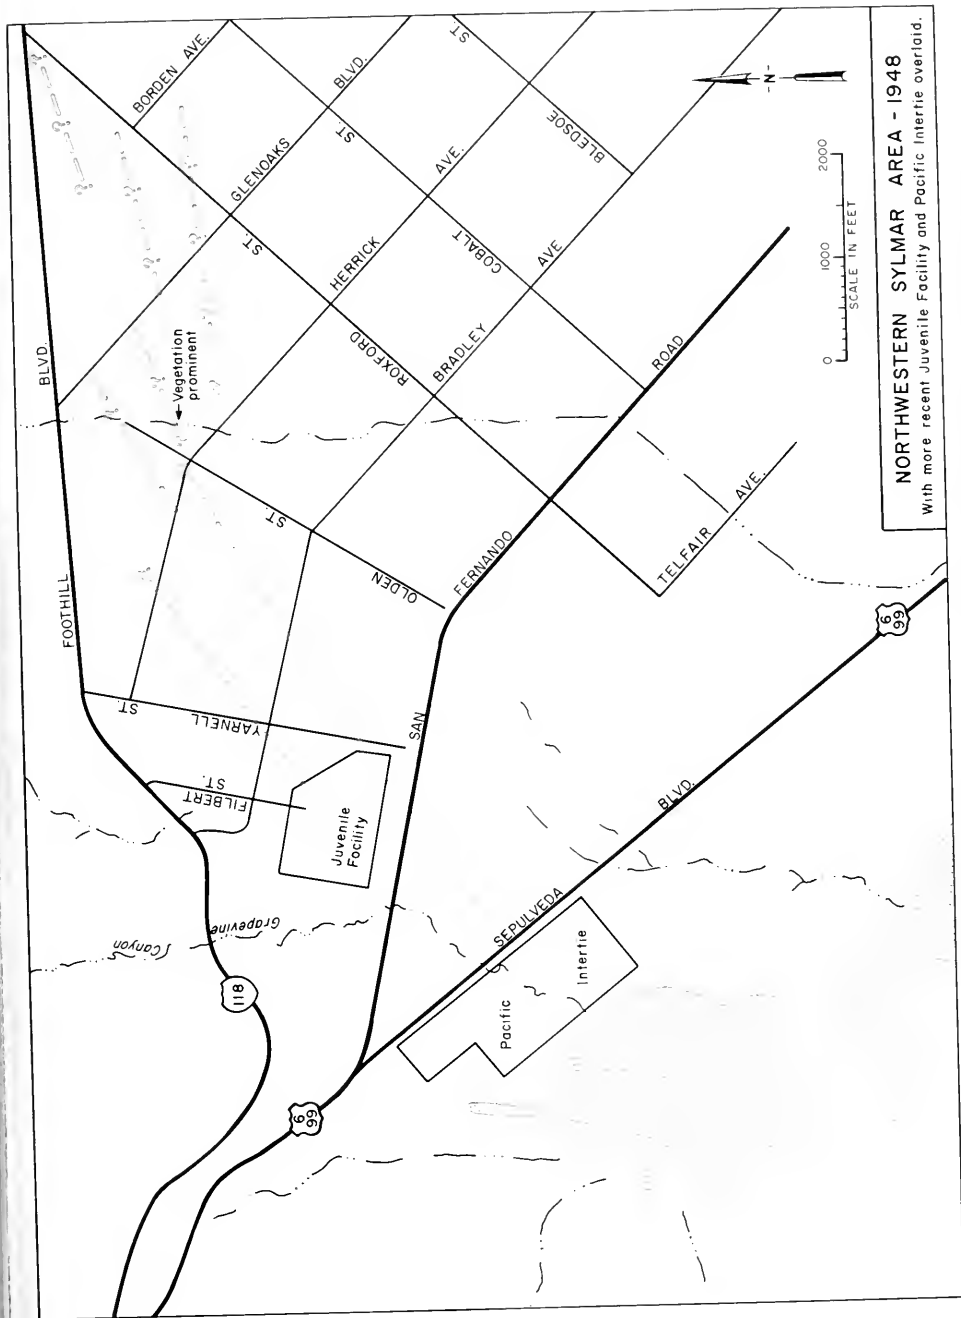
Figure 1. Lineaments interpreted from aerial photographs are traces of probable (dashed) and possible (questioned) faults which extend mostly concealed across alluvial area of northwestern Sylmar. Photograph is drawn from 1948 photograph with Juvenile Hall and Golden State Freeway of later years added. Development of cracks and intense shaking in area may be partially related to possible subsurface activity along these probable and possible faults (see plates 2 and 3).

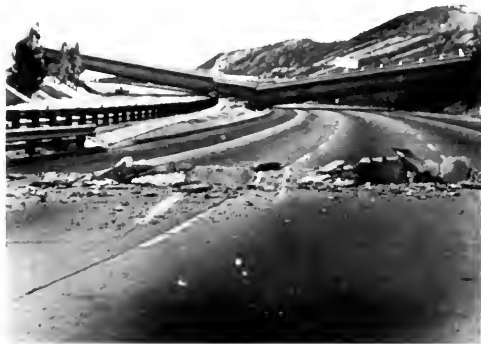
Reservoir segment, where it occurred wholly in man-made cuts (58). This east-trending, north-dipping fault displayed both reverse and left-lateral sense of movement where it broke the Golden State Freeway. On the east edge of the San Diego Freeway, successive concrete drain segments for a distance of about 90 m (300 feet) north of the fault were overthrust south at the seams a total of about 20 cm (8 inches) (photo 12).

Photo 12. View north showing principal break of Reservoir segment of San Fernando fault zone where it cuts across the San Diego Freeway about 300 feet south of collapsed southeast-bound bypass bridge of Golden State Freeway. Broken pavement here was repaired soon after photograph was taken on morning of earthquake and was not examined by Division of Mines and Geology. Later examination of area showed that seams in concrete drain along east side of freeway from fault break north about to site of collapsed bridge had cumulative southward compression of approximately 8 inches (20 cm). Photo courtesy of the California Division of Highways.

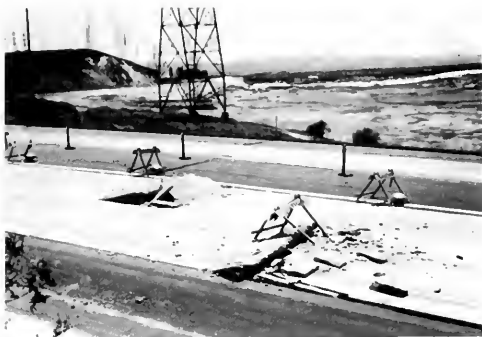
The second relatively prominent surface break cut a ridge capped by thin older alluvium southwest of the Golden State Freeway (61). The break seemed similar to those which lay 5 $\frac{1}{2}$ km (3 $\frac{1}{2}$ miles) to the east in the Harding School area. The strike of the break was northwestward, essentially parallel to the underlying Saugus Formation. It was about 135 m (about 450 feet) long, with the north side down a maximum of about 15 cm (6 inches). Near the northwest end, a mole track lay just southwest of the principal cracks. There were many additional surface effects of the earthquake south and southeast of this break. They included ground cracks, severe cracking and settling of the fills for the freeway, and cracking of a concrete channel west of the freeway (60) (photo 13).

Photo 13. Compressional breaks in southeast-bound lanes of Golden State Freeway bypass, approximately at contact between fill to right and cut in Saugus Formation to left. View south also shows slide mass of Lower San Fernando Dam in now-empty reservoir in right background. Small landslides formed in hill in left background, and rocks fell from bore cut during the shaking.

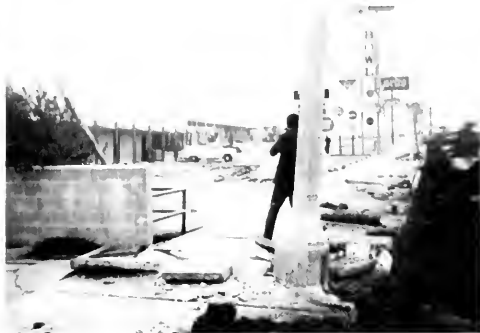
Photo 14. Badly damaged shopping center and bowling alley on southwest side of Glenoaks Boulevard at Hubbard Street; buildings razed since photograph taken. View west, about 215 m (700 feet) southeast of Hubbard Street, shows fault break of Sylmar segment extending across asphalt parking lot as welllike feature; in foreground, portion of concrete sidewalk was thrust about 50 cm (20 inches) south; underground utility lines and storm drain in Glenoaks Boulevard to right were extensively damaged, as were businesses to right out of view.

There was extensive damage along the Sylmar segment to shopping centers and other businesses at Glenoaks Boulevard and Hubbard Street, to many residential houses, to a modern apartment building, and to the Foothill Freeway, as well as to streets and utility lines and to two buried flood control channels. A gas line along Glenoaks Boulevard burst in several places where breaks of the segment crossed it.

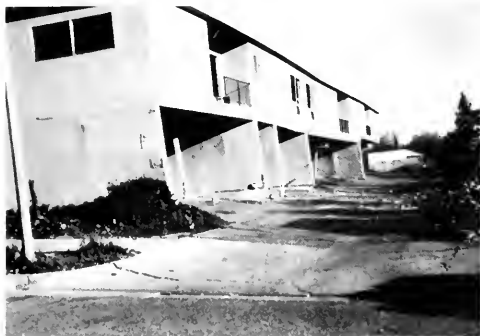
Photo 15. Severely damaged and leaning modern apartment building, now razed, formerly at southeast corner of Foothill Boulevard and Harding Avenue (locality 81). View northeast. Fault break of Sylmar segment extended through corner of building in for carport and crossed Harding Street to right of camera point. Building was constructed on older alluvium.

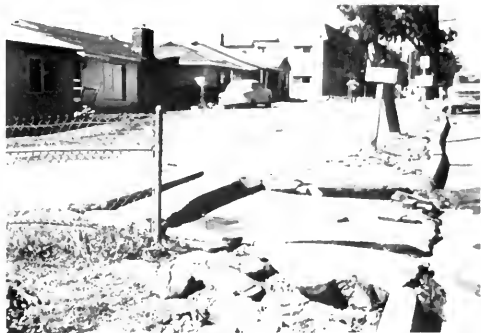
Photo 16. Surface break of Sylmar segment of San Fernando fault zone extends northwest along edge of Foothill Boulevard toward houses and modern apartment building (photo 15). In foreground, concrete driveway and its asphalt approach to boulevard were broken into short segments which were successively overthrust. In February 1972, house next to site of apartment was jacked-up, and a new foundation was constructed beneath it; severely damaged middle house was unoccupied.

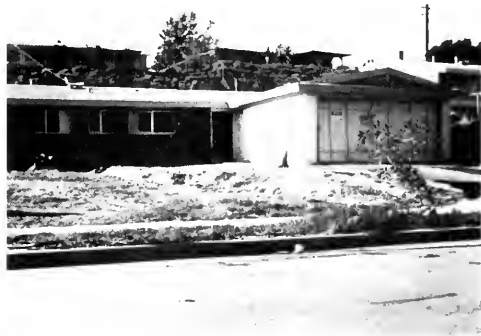
Photo 17. View west across Newton Street showing scarp about 30 cm (12 inches) high along fault break of Sylmar segment of San Fernando fault zone. Break extends into southwest edge of house which was later razed. Most houses along fault break in this neighborhood have been razed; most houses on southern side of fault were not badly damaged, but houses on north (up-faulted) side were generally badly damaged, though repairable. Houses partly or wholly on fills in this area commonly were damaged by the effects of shaking.

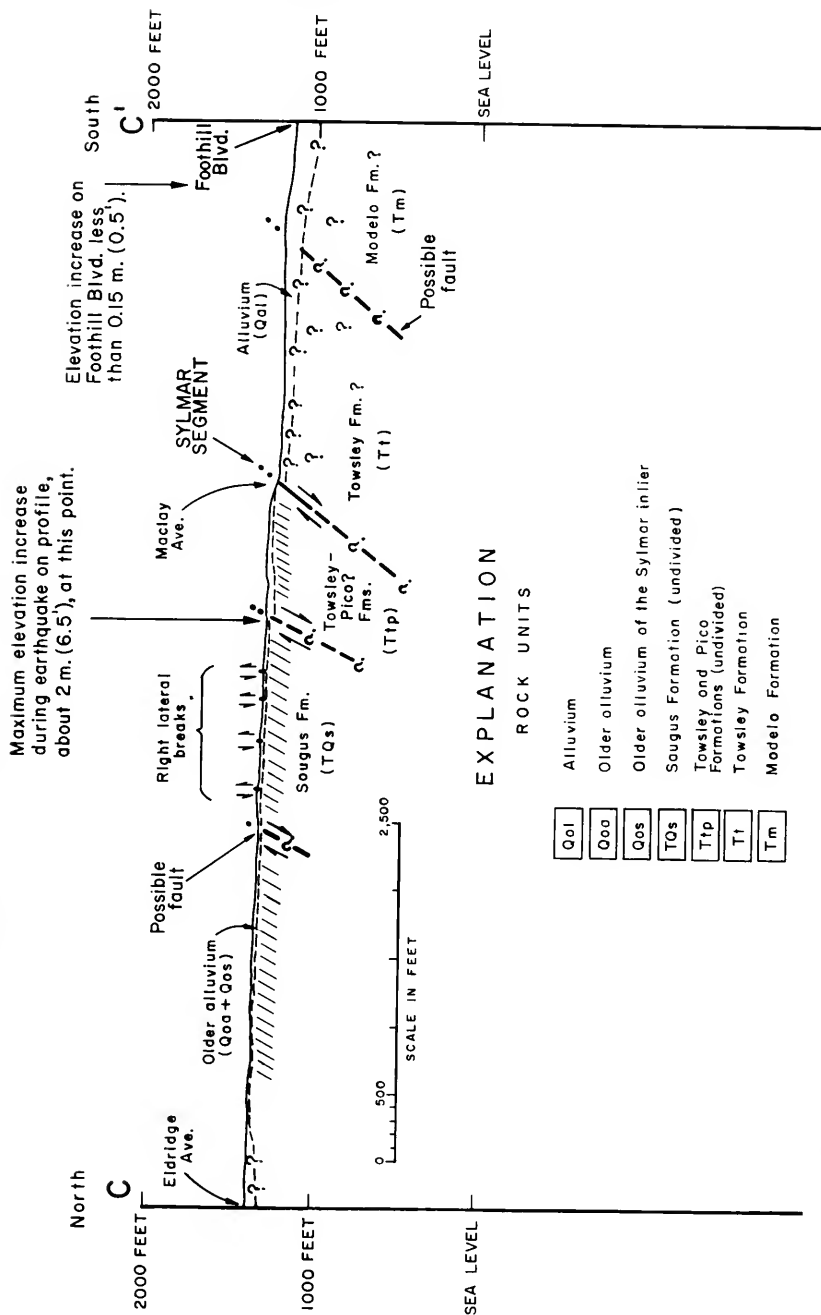
Figure 2. Cross section extends from north to south at a point about 300 m (1000 feet) east of intersection of Foothill Boulevard and Macloy Avenue. Faults are essentially along bedding of north-dipping clastic sediments of late Miocene to early(?) Pleistocene age. Offset of contact between bedrock and older/younger alluvium along faults is partly surmised.

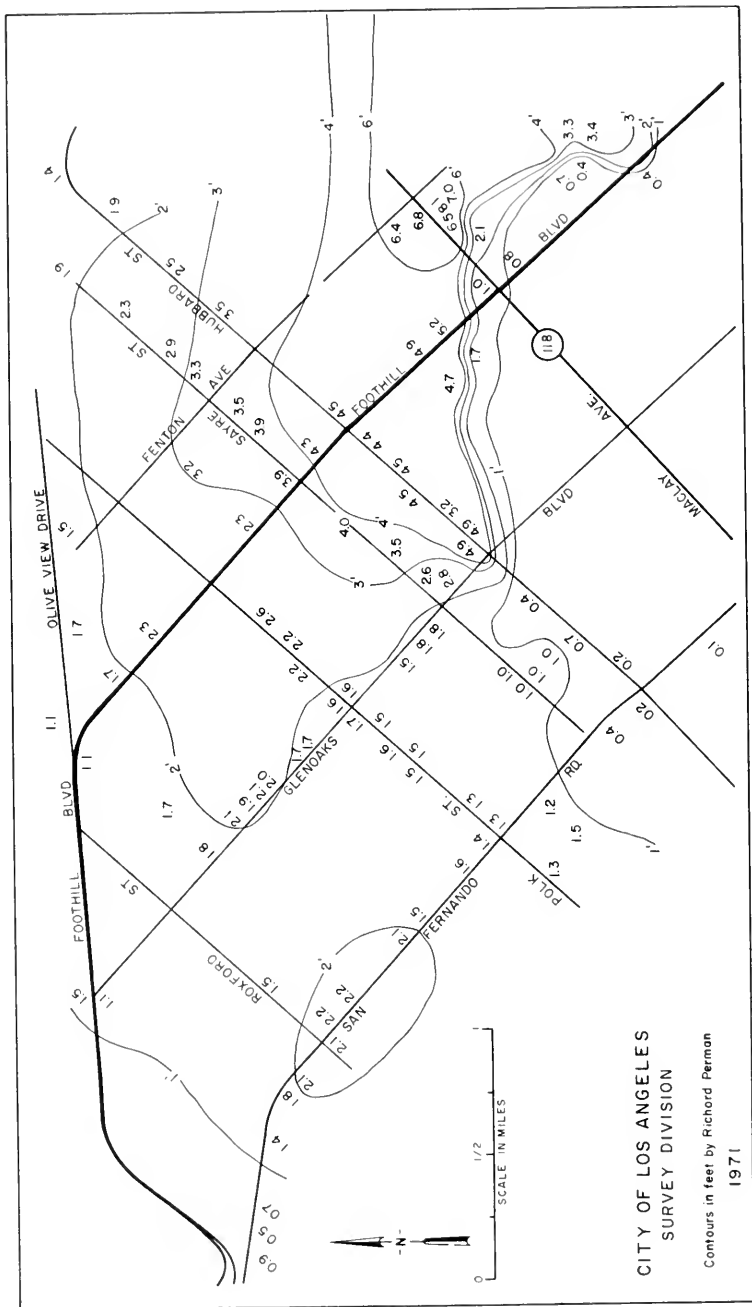
The principal trend of maximum elevation increase in the Sylmar area during the earthquake extends east from the intersection of Glenoaks Boulevard and Hubbard Street to a point just south of Lopez Dam in Pacoima Wash (figure 3). The trend lies essentially along the north edge of the Sylmar segment. The point surveyed by the City of Los Angeles which had the greatest rise in elevation is about 180 m (600 feet) north of where the principal fault of the segment crossed Newton Street (84). This rise was 2.47 m (8.1 feet). On the east end of the trend, the intersection of Glenoaks Boulevard and Hubbard Street rose nearly 1.5 m (5 feet), from an elevation of about 1179 feet to about 1184 feet; whereas to the southwest about 410 m (1350 feet), the intersection of Hubbard Street and Herrick Avenue rose only 0.12 m (0.4 feet) from its previous elevation of 1149 feet. This rise in elevation (up-dip to the north) of the principal reverse faults of the Sylmar segment suggests that the ground surface here bowed upward slightly during the earthquake (figure 2). Thus a sense can be gained of how the area of older alluvium north of the principal faults has begun to "grow" into hills during faulting during earthquakes.

Figure 3. Trend of maximum elevation rise during the earthquake extends from near the intersection of Glenoaks Boulevard and Hubbard Street to beyond the area to the east at a point just south of Lopez Dam in Pacoima Wash. This trend is essentially parallel to the fault breaks of the Sylmar segment, about 250 m (800+ feet) north of the south edge of the segment. The point of maximum elevation rise (8.1 feet) in the Sylmar area lies 123 m (400+ feet) south of the intersection of MacLay and Fenton Avenues. The two-foot trend in the northwest part of the area shown lies along the southeast flank of the Mission Hills syncline.

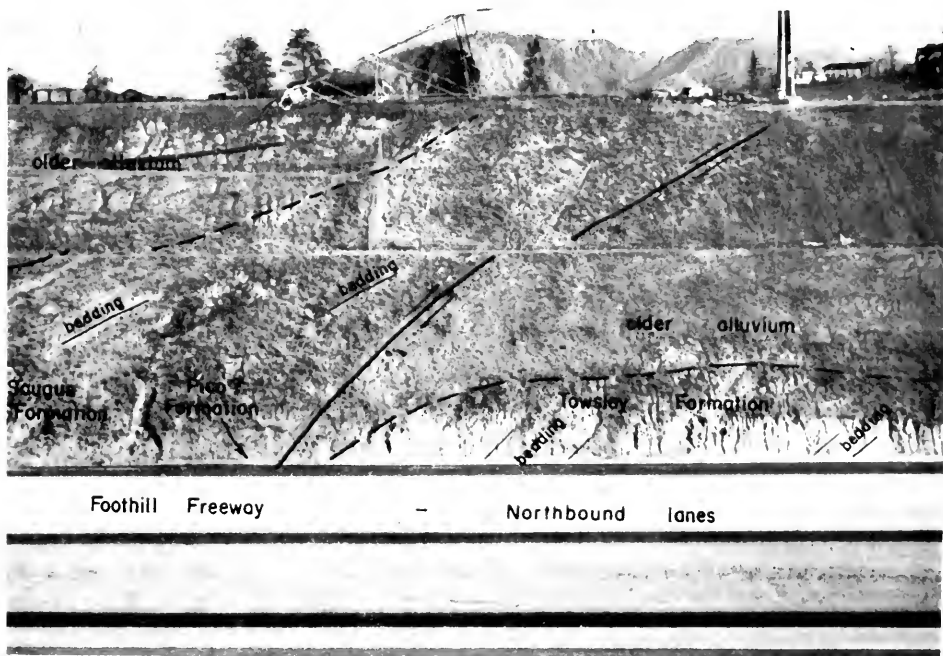
The most southerly of these breaks was exposed in the Foothill Freeway (82) (photo 18); this fault broke very slightly left laterally and down slightly to the south at the northeast edge of the freeway. In the northeast freeway cut, the fault seemed to dip steeply north with total pre-earthquake reverse displacement of perhaps 30 m (100 feet) or more of the very gently north-dipping angular unconformity between the Towsley Pico/Saugus sequence (Plio-Pleistocene) and the overlying older alluvium (Pleistocene).

Photo 18. View northeast across Foothill Freeway (locality 82) shows east-trending reverse fault which dips $70^{\circ} \pm$ north. Very small displacement occurred along fault during earthquake. Total late(?) Quaternary reverse displacement on fault of angular unconformity between Pliocene sedimentary rocks and Pleistocene older alluvium here is estimated to be about 30 m (100 feet). Power line tower was not toppled by earthquake.

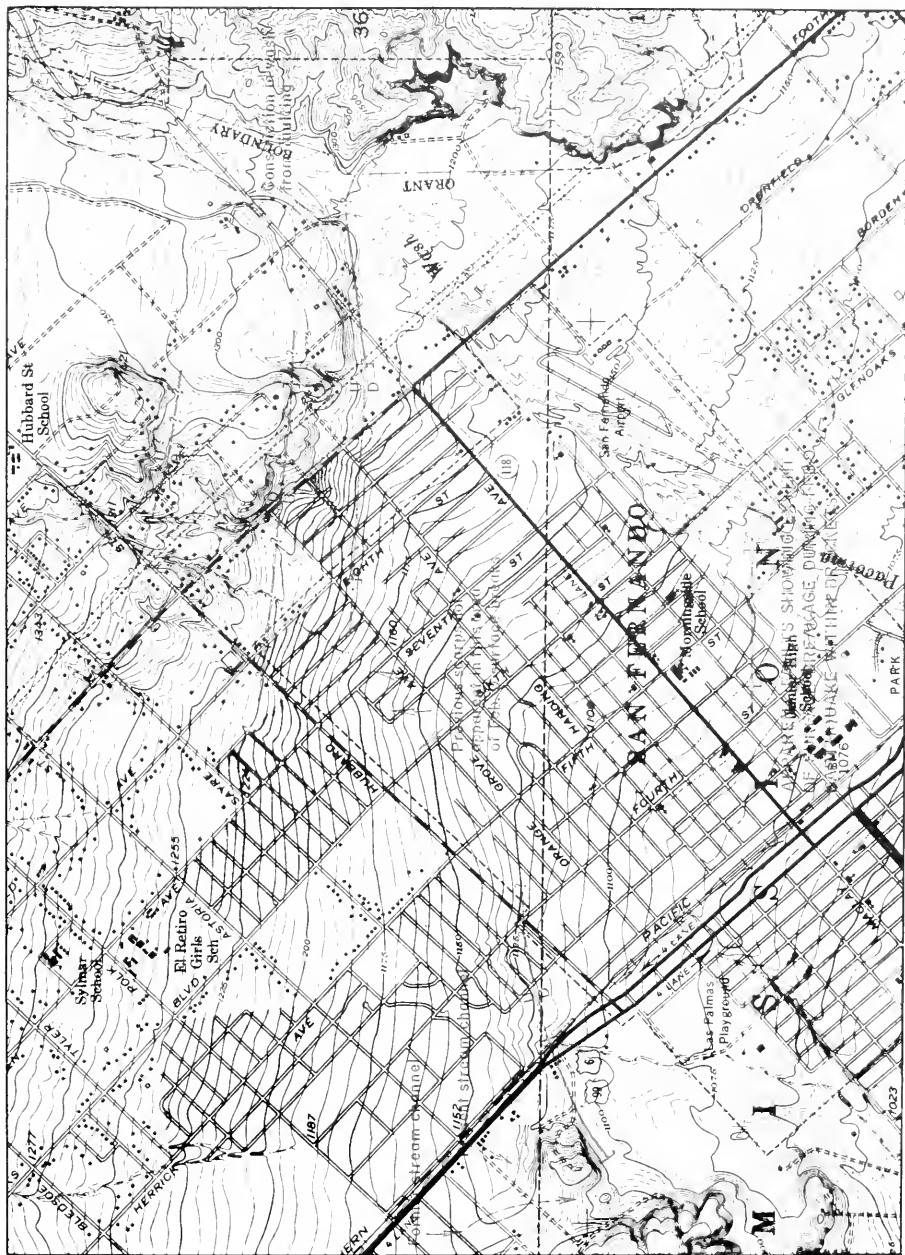
Figure 4. Apparent fault scarps previous to February 9 earthquake are plotted along sharp to gentle linear breaks in slope, as defined by pattern of contours. Map is portion of 1953 edition of San Fernando quadrangle (topography by plane table methods, 1924-1934); newest, 1966 map has 10- and 40-foot contour intervals and does not delineate scarp features as well. Fault north of Sylmar segment had minor displacement during February 9 earthquake (see also photo 18); and second postulated fault north of Sylmar segment had no apparent surface breakage.

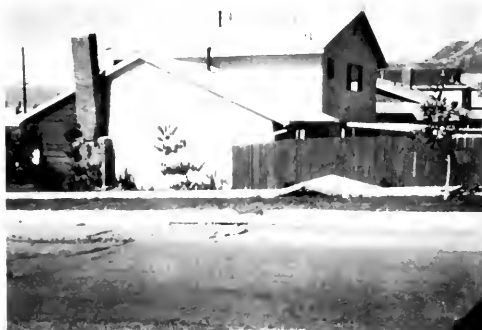
There were relatively strong street cracks and damaged houses in the vicinity of Cobalt Street and Dronfield Avenue in the younger alluvium, but they could not be related to faulting (72); similar street cracks and damage in the vicinity of Sayre Street and Eldridge Avenue may be related to possible fault activity at depth (87). A strong break across Astoria Street just northeast of Garrick Avenue was probably formed by the effects of compaction or compression during shaking in a small fill for part of the street there (44) (photo 19).

Photo 19. Compressional break in sidewalk, parking, and curb of Astoria Street about 30 m (100 feet) northeast of Garrick Avenue (locality 44). View is northwest, nearly half a mile southwest of Veterans Administration Hospital. Feature does not extend beyond street area and therefore probably cannot be attributed to faulting; more likely it was caused by the shaking of the earthquake, perhaps acting on a relatively weak fill in this portion of the street. House was not badly damaged.

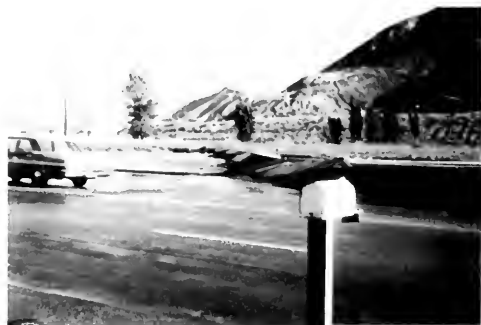
Surface expression. In the region between Little Tujunga Canyon and Pacoima Wash, the most spectacular and continuous surface effects of the earthquake lie along the Tujunga segment of the San Fernando fault zone. Surface breaks extend from the vicinity of the San Fernando Industrial Park eastward along Foothill Boulevard where, just east of Vaughn Street, the northeast sidewalk and curbing were lifted abruptly 85 cm (2.8 feet) relative to the pavement (90) (photo 1). The breaks continue across the

Photo 1. Frontal fault scarp of the Tujunga fault segment on Foothill Boulevard just west of the Foothill Nursing Home, which has since been razed (locality 90, plate 3). Note water in street from ruptured water mains. Photo taken by F. Harold Weber, Jr., at 9:00 a.m., February 9, 1971.

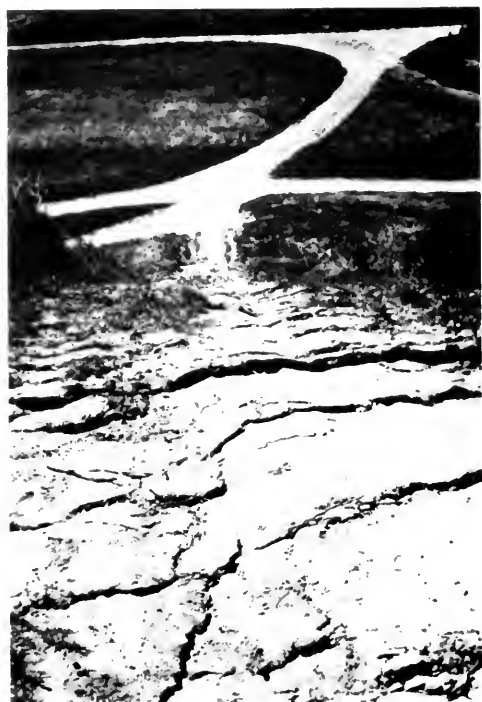
mouths of Lopez (photo 2), Kagel, and Little Tujunga Canyons and disappear near the mouth of Casara Canyon. In some places (93, 118), the breaks of the Tujunga segment define a single continuous fault-line scarp, whereas in other places the segment consists of numerous interrupted, locally multiple (104) scarps and cracks that very closely approximate the change in slope at the base of the foothills. Asymmetrical compression ridges and mole tracks are the southernmost surface features of thrust faulting. Locally, abundant tensional cracks and high-angle fault scarps are common immediately north of the thrust fault scarps (94) (photo 3).

Photo 3. View south and downslope of numerous tension cracks in white Modelo Formation siltstone above Tujunga fault segment scarp north of the end of Hoyt Street (locality 94, plate 3).

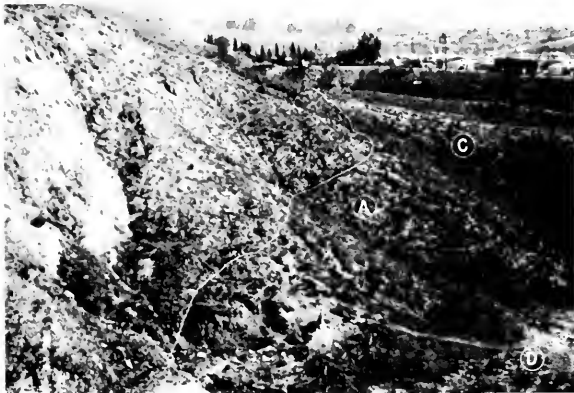
Photo 4. View eastward along the western part of the Tujunga fault segment about 213 m (700 feet) northeast of Foothill Boulevard. Scarp (A) of the Tujunga fault segment, which separates north-dipping siltstone and sandstone of the Miocene Modelo Formation (B) from dark reddish-brown alluvial debris and alluvium (C), which has been dissected and is above the level of the modern alluvium (D). Close inspection of the attitude of the contact in this vicinity would have revealed before the earthquake that the Modelo Formation does indeed rest upon alluvium. Photo taken by F. Harold Weber, Jr.

slopes west of Lopez Canyon (photo 4). Exposed above the level of the modern alluvium are remnants of a distinctive, mappable deposit of poorly sorted, weathered, older colluvium and alluvium possibly of debris flow origin. Both White (1937) and Howell (1949) mapped this unit, but only White placed a fault between it and the Modelo sandstone to the north. In addition to the easily recognizable character of this material, an abrupt change in the bearing of the gullies that dissect the slopes from S. 20° E. in the steeper Modelo sediments to S. 35°–45° W. in the older alluvium at the contact of the two hints at the change in geological conditions. An accurate plot of the trend of the contact across the topography between the Modelo Formation and the older alluvium at one locality in particular (photo 4) demonstrates that the Modelo sediments must indeed overlie the alluvium.
